This is a Factual Investigative Update of a CSB investigation into a multi-fatality incident resulting from the catastrophic failure of a pressure vessel.<sup>1</sup> It provides the facts and findings established by the investigation team to date, which is subject to revision and updates as the investigation proceeds. This document identifies a path forward for a number of potential investigative areas of inquiry that may yield lessons for safety improvements.

### Incident Overview

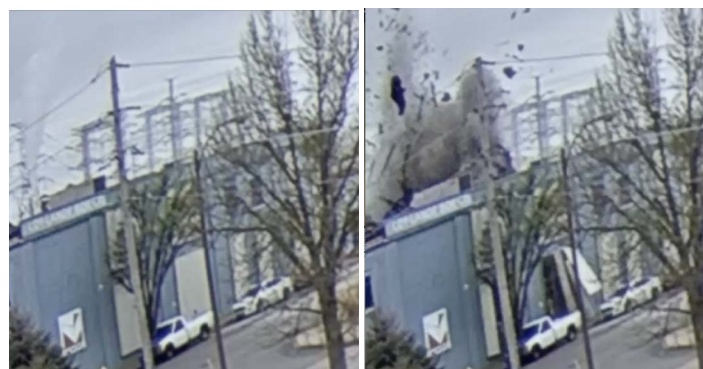
about 350 pounds of TNT.<sup>8</sup> Some of that energy dissipated when the escaping steam condensed to water, but the surveillance video from a nearby custom work truck shop clearly shows the power of the explosion and the effect on the building (Figure 1), as does the damage evident after the event.

**Figure 1.** Before and after photos for the explosion - Kranz video

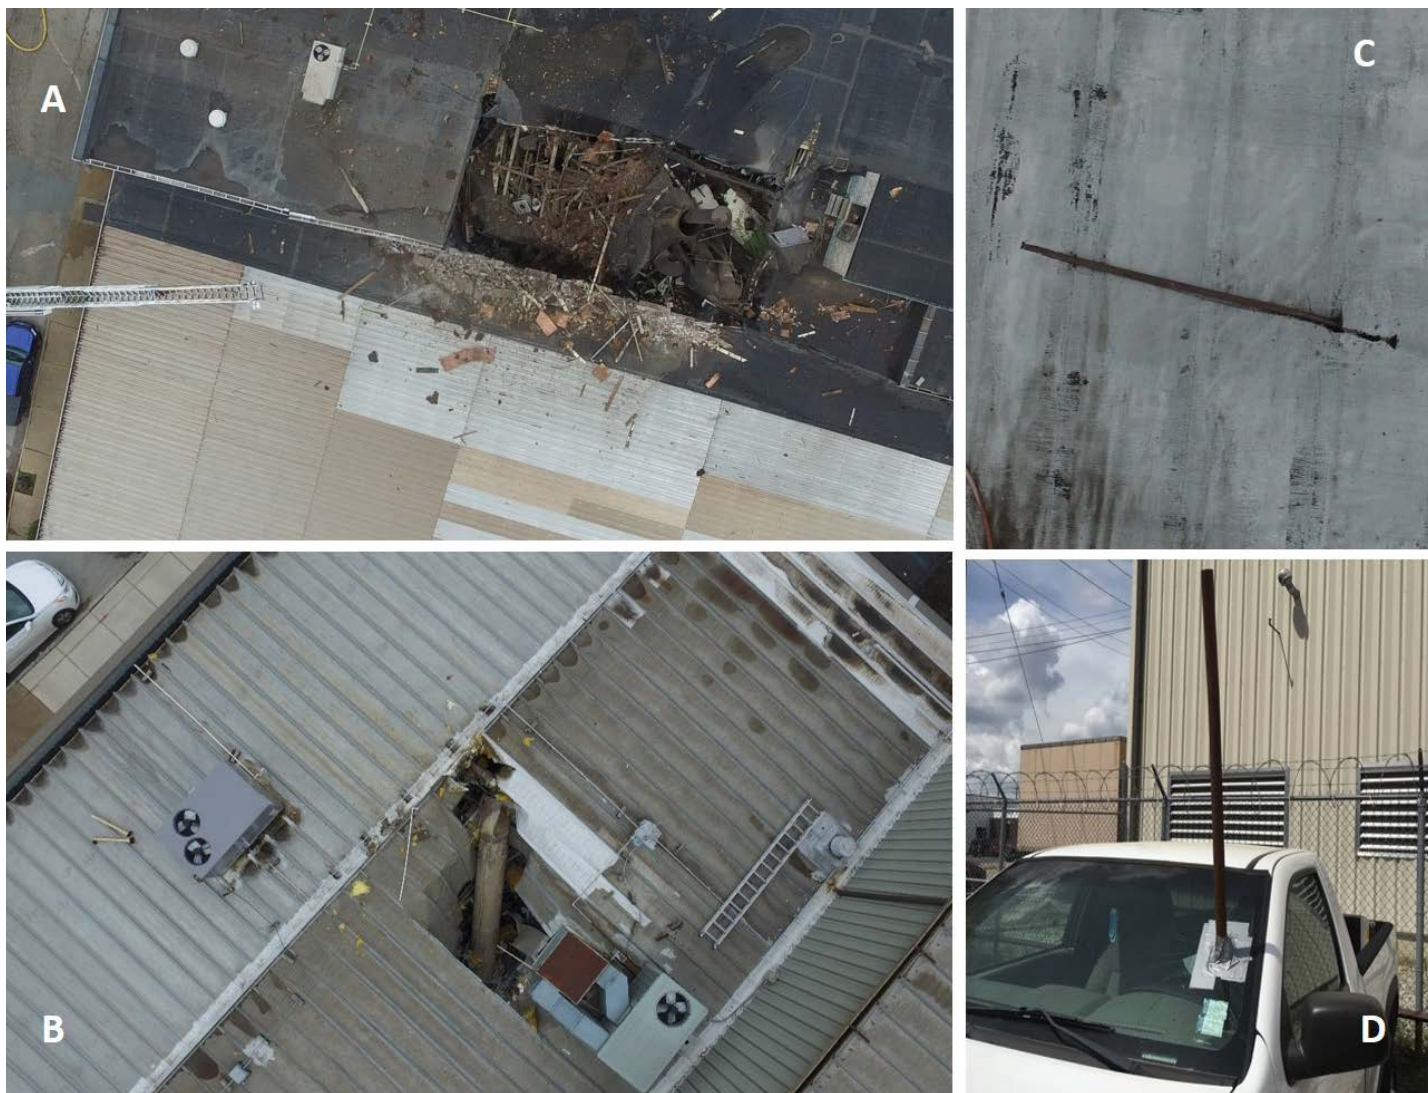
The force of the steam explosion exiting the bottom of the SCR destroyed a large portion of the LLBC facility, and launched the storage tank like a rocket through the roof (Figure 2, A). One LLBC employee was fatally injured, and a second was left in critical condition.

As it fell, the SCR crashed through the roof of Faultless Healthcare Linen's<sup>9</sup> property at 2030 S. Broadway, fatally injuring three individuals (Figure 2, B).

Various pieces of piping and debris from the explosion also crashed into the surrounding areas. A third building at 400 Russell Boulevard, owned by Pioneer Industrial Group, suffered significant mechanical and water damage when a large piece of pipe from the Loy-Lange site punctured the roof and ruptured a portion of its water sprinkler system (Figure 2, C and Figure 3). No injuries occurred at this third site. An approximately 7 foot long section of about 1.5 inch pipe also speared down through the windshield of a truck parked adjacent to the Faultless property and embedded into the dashboard and floorboard (Figure 2, D and Figure 3).

**Figure 2.** Damage as a result of the incident

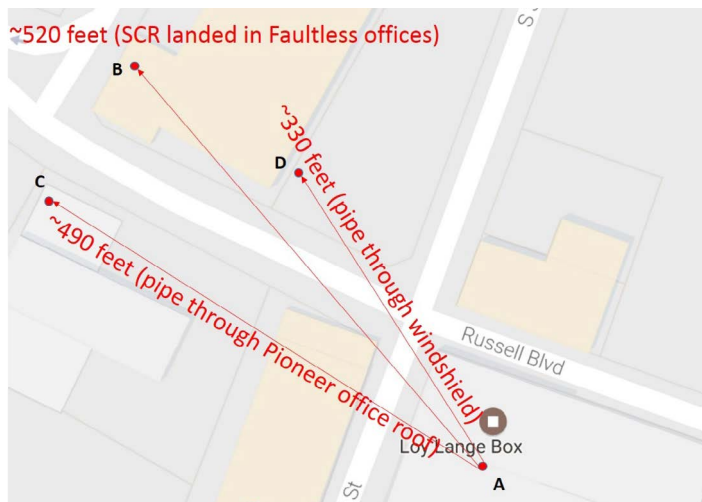
**Figure 3.** Debris map

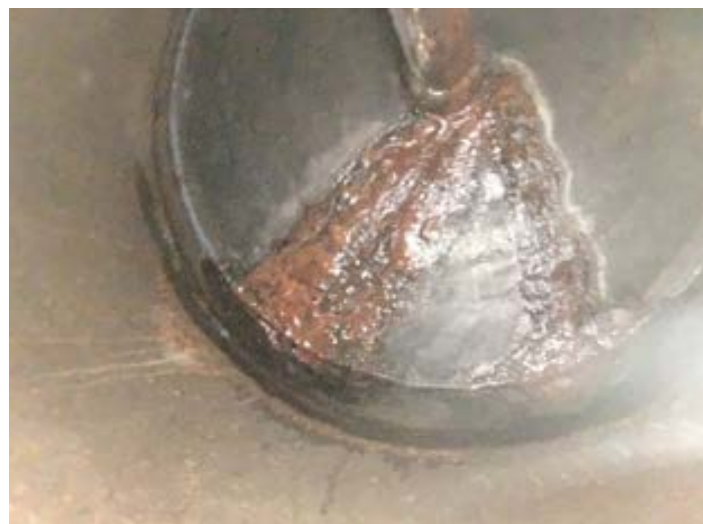
(Figure 5). The phone was extended in through the large hole in the skirt that was cut in 2012; the camera is looking straight up at the SCR bottom tank circle and drain line inside the skirt. The weld line can also be seen between the 6"-wide ring of original bottom head and the tank circle installed in 2012.

**Figure 5.** Photograph of SCR bottom head leak, taken March 31, 2017

Figure 5 indicates that leaks are coming from at least two distinct and significant sections of the circumference of the SCR. Further, the wet area, most apparent on the left, is originating from the 6" ring of the original head left behind by the 2012 repair.

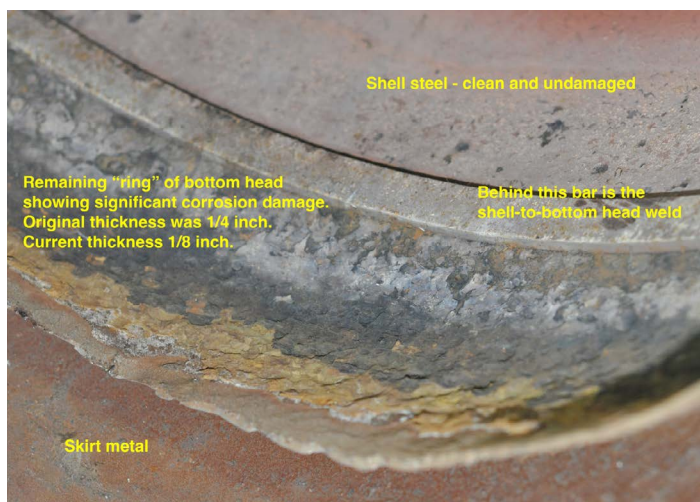
First, the inspection of the bottom of the SCR after the incident revealed that the entire bottom tank circle was gone, but that a significant portion of the 6" ring remained, hanging down around the entire circumference. See Figure 6 and Figure 7.

**Figure 6.** Photo showing 3-4" highly damaged section of the original bottom head remaining in SCR

Evident from this photo is the extreme difference between the clean condition of the steel that makes up the shell (above the weld) versus the extremely corroded steel of the remnant of the original bottom head (below the weld). The investigation team found that this extreme line of demarcation between good metal above and damaged metal below extended consistently around the entire circumference of the SCR. The clean condition of the inside of the shell can also be seen in Figure 8.

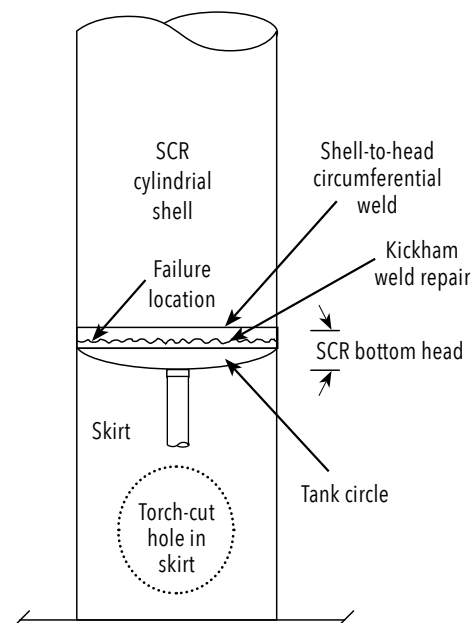
**Figure 7.** Drawing of various parts of the SCR

Figure 7 is a drawing that illustrates the various parts of the SCR, the failure location, and the pieces depicted in the photographs.

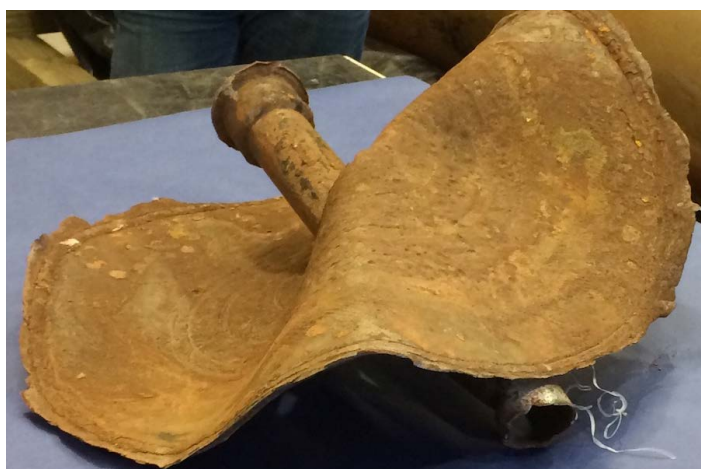
The second piece of evidence supporting the assignment of cause is based on an examination of two metal artifacts found within the upper portion of the SCR lodged at the spargers (Figure 8)<sup>29</sup>

**Figure 8.** Close-up of bottom tank circle and portion of bottom piping showing weld seam and, outside of the seam, the thinned original bottom head “ring” material

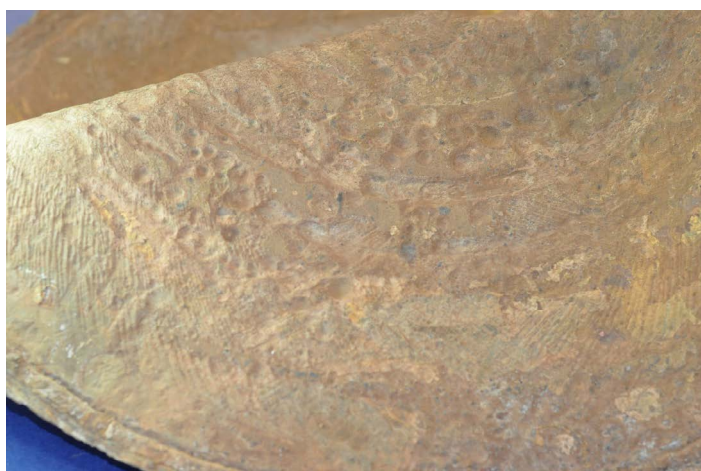
When the artifacts were removed, they were determined to be the entire tank circle that had been added during the 2012 repair and a portion of the bottom piping, Figure 9. The entire weld is intact, and around the outside edge of the weld is a portion of the 6" ring that mates with the portion that is still attached at the bottom edge of the vessel shell. Initial measurements of the remnants of this ring were as thin as 0.08". The metal of the tank circle, installed in 2012 and in service for 4.5 years, also displayed "surface of the moon" corrosion characteristics, and has thinned from the original 0.25" to about 0.2" (Figure 9). If the corrosion rate is assumed to be linear with time, this rate of corrosion of the tank circle is consistent with the rate on the original bottom head, as evidenced by the remaining ring material.<sup>30</sup> The corrosion in the bottom of the SCR was still occurring, as it did before the 2012 repair. Again, the team will rely on metallurgical testing and analysis in order to develop a further understanding of the corrosion damage.

**Figure 9.** Interior “surface of the moon” condition of the tank circle that separated from the SCR vessel during its catastrophic failure on April 3, 2017. The tank circle was installed in 2012

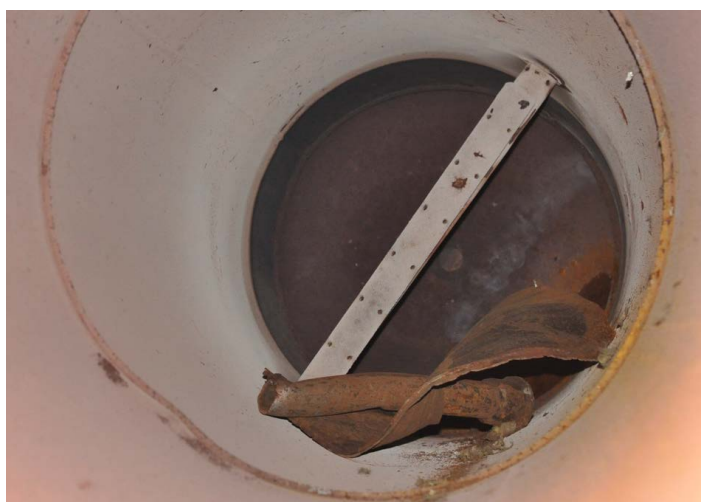
**Figure 10.** Piece of bottom drain piping and a section of the bottom head
